# Home Inspection Report

86 Right Lane, Rightsville WA, 6006  
Inspection prepared for: John Wright  
Inspection Date: 28/2/2010 Time: 2.30 pm  
Age: 1982  
Weather: Fine and hot

Inspector: Paul Antonelli  
Phone: 0400321451  
Email: paul@resicert.com  
[www.perthhomeinspector.com.au](http://www.perthhomeinspector.com.au)

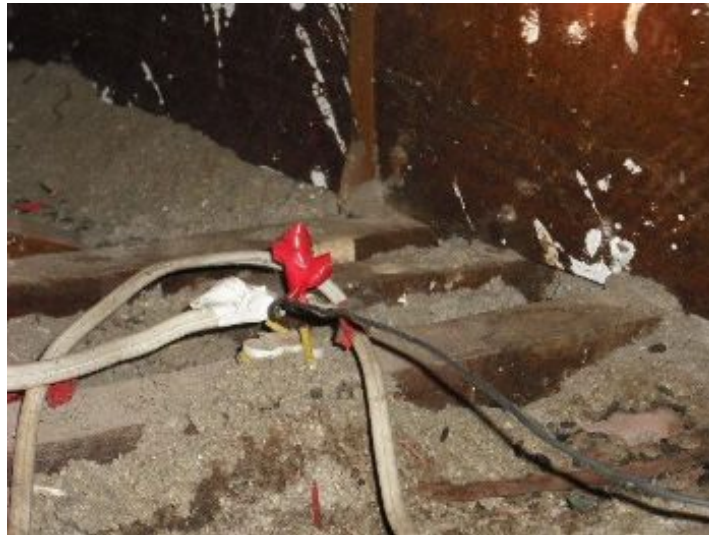
- Wire ends are outside of a Junction Box, which is a potential shock or electrocution hazard.

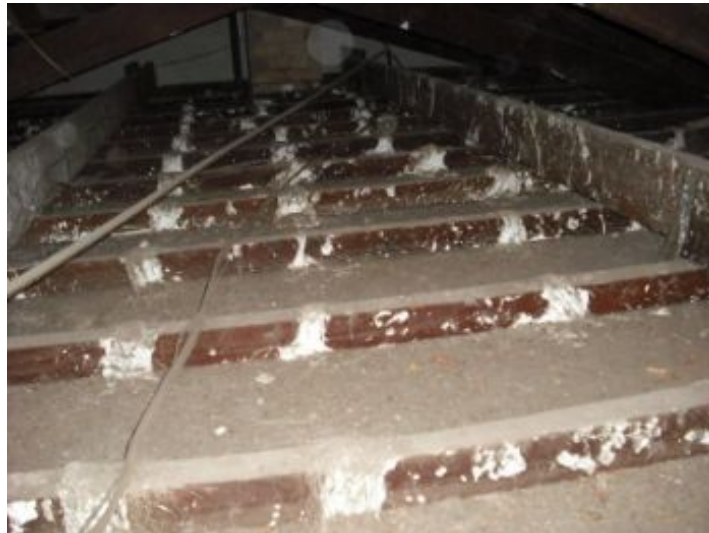
- There is no insulation in the ceiling space. It is recommended that insulation be added to improve the efficiency of the home. You may be eligible for the Federal Government rebate for this.

No insulation

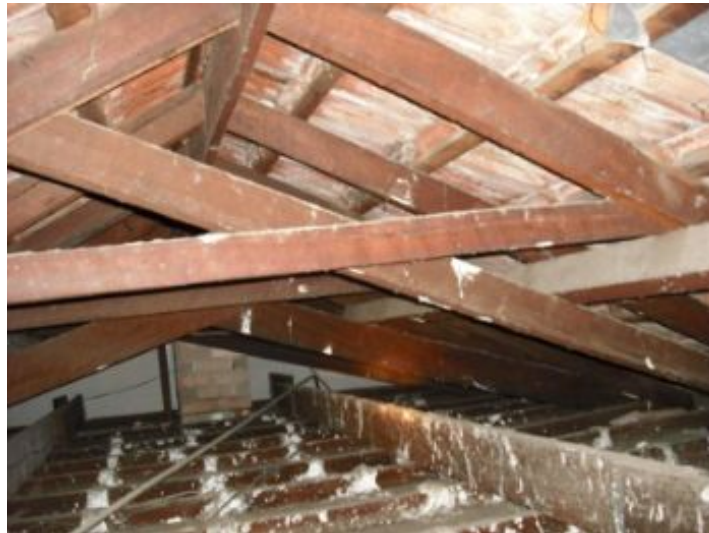
**Observations** The timber roof structure appears sound, although some minor deflections due to settling in over time were noted.

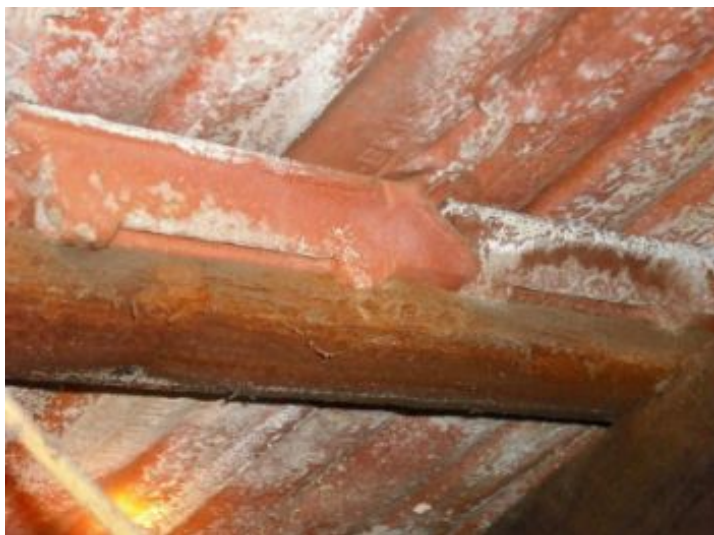
- There are some clay tiles which are fretting within the roof space. This is often the case for these type of tiles close to the coast. This should be monitored into the future, and where necessary, tiles should be replace
- A number of ridge and hip capping tiles are loose due to cracks in the bedding cement. This is not unusual for a tiled roof, and is often caused by normal movements in the roof frame. This work is required to be undertaken to prevent roff leakage from taking place.
- Vine has entered the roof in between the tiles and will be a source of leaks in the future. This requires attention.

Fretting tiles

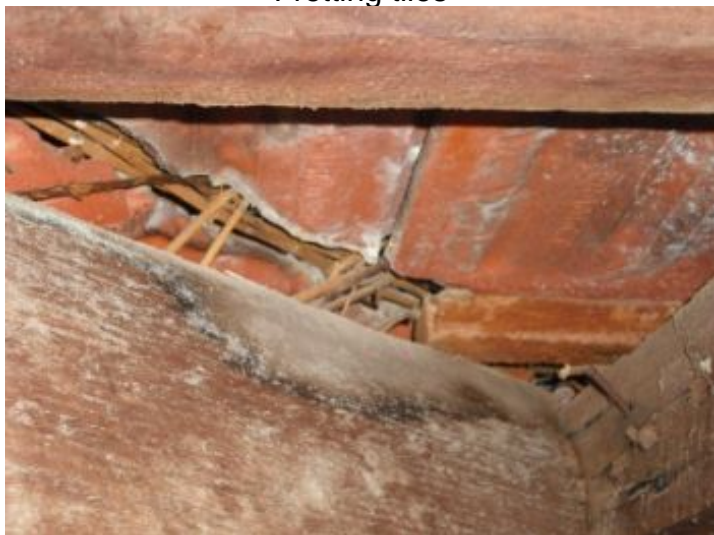
Vine in roof space

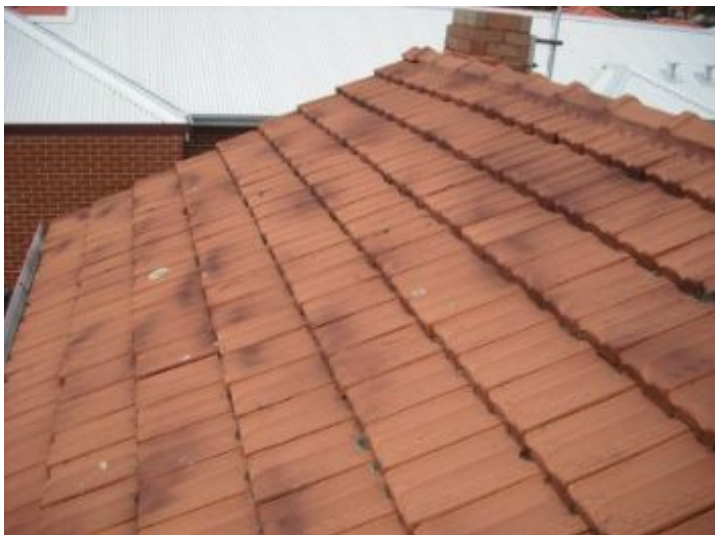
Ridge capping deficient

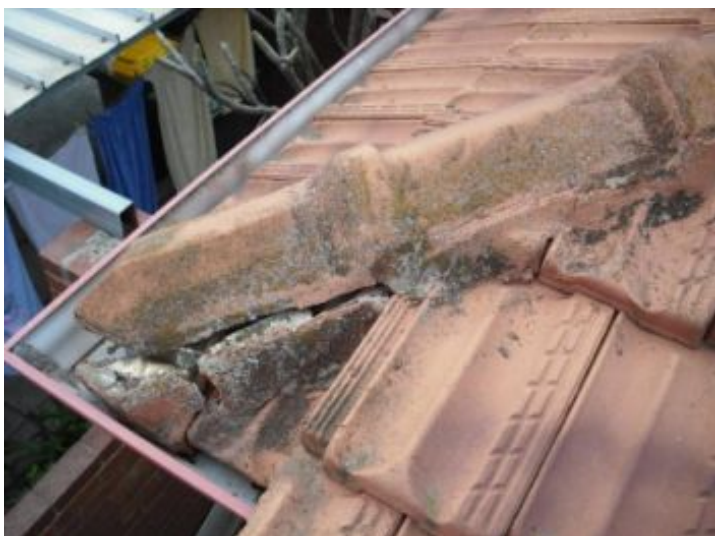
Hip capping deficient

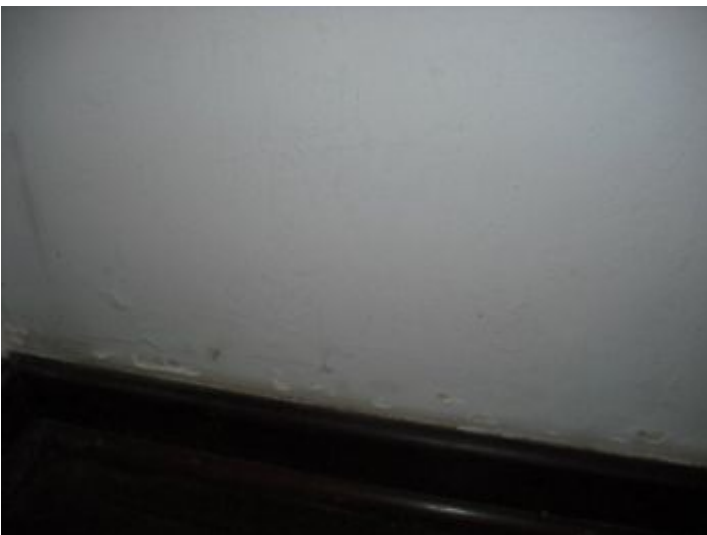
- Due to normal minor differential settlement of the foundations, small cracks have appeared through internal walls at various places throughout the house. These cracks do not appear to have affected the overall structural integrity of the house and can be patched normally.
- There is evidence of dampness in the wall which is adjacent to the shower. This is a result of the seals and tile joints not functioning correctly. The tiles and joints should be checked for leaks and resealed to prevent any further dampness. Then the wall should be allowed to dry out fully before being repaired.

Dampness in walls

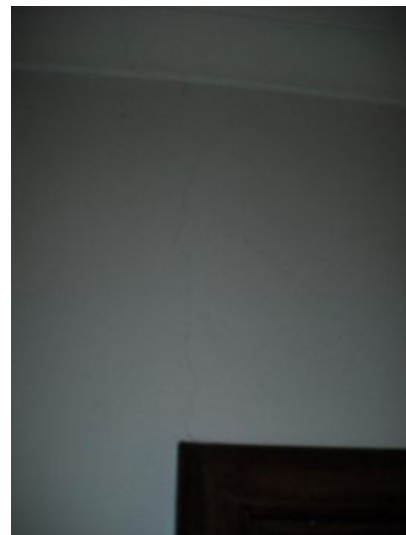
Wall cracks present

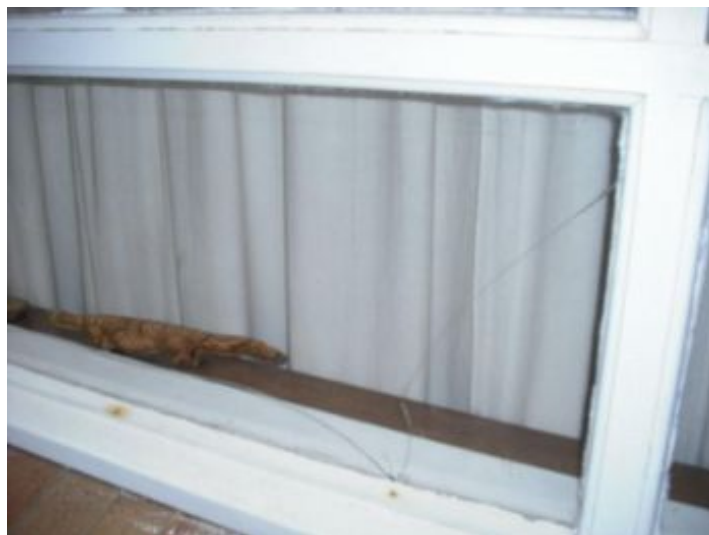
- Broken/cracked glass pane noted, repairs needed.

Cracked pane

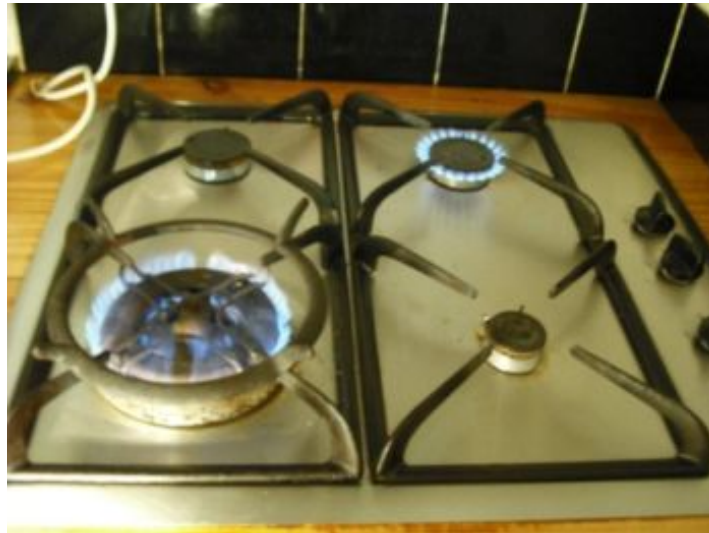
Observations:  
 • The cook top operated to normal user controls. The self igniter on two of the hotplates is not working and requires servicing.

Gas cook top

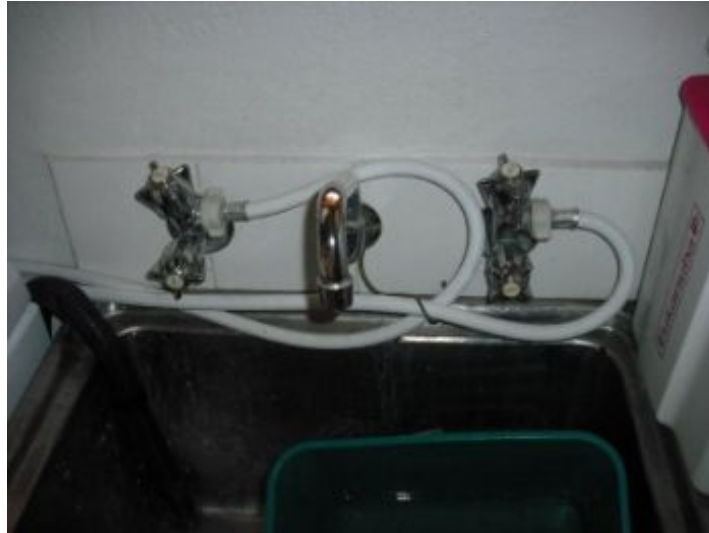
- The trough and related components are functional.
- The hot & cold water supplies are reversed. This is not a functional problem but to someone who is not familiar with this condition unexpected hot water could scald them. We suggest contacting a qualified plumbing contractor to repair.

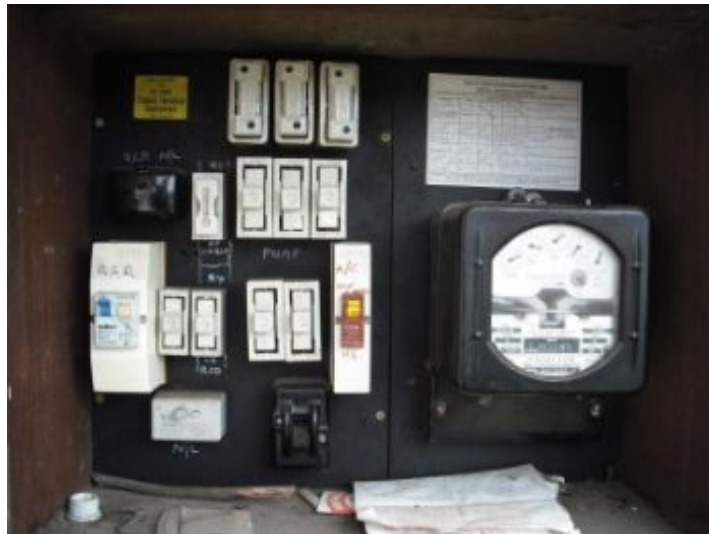
- One RCD (Safety Switch) has been installed. In line with the latest regulations another RCD safety switch is required to be installed prior to settlement. This is required to be carried out by the vendors.

One RCD. Another required.

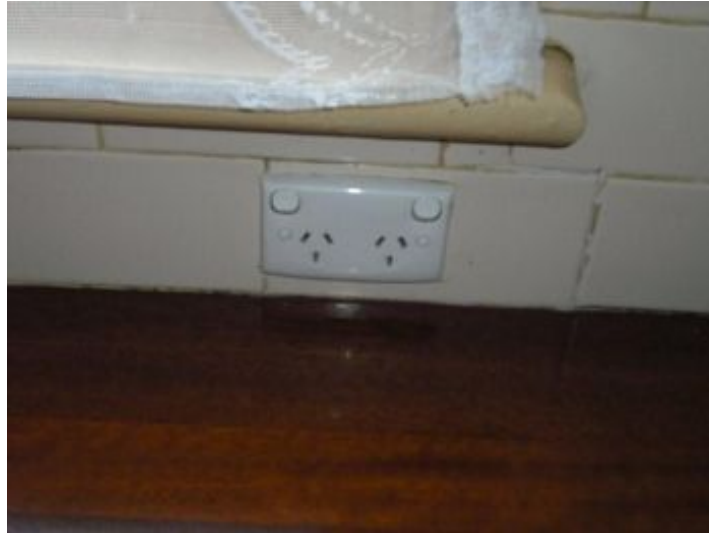
- There is a loose power point fitting located in the bar area that needs refixing to the wall.

Loose power point

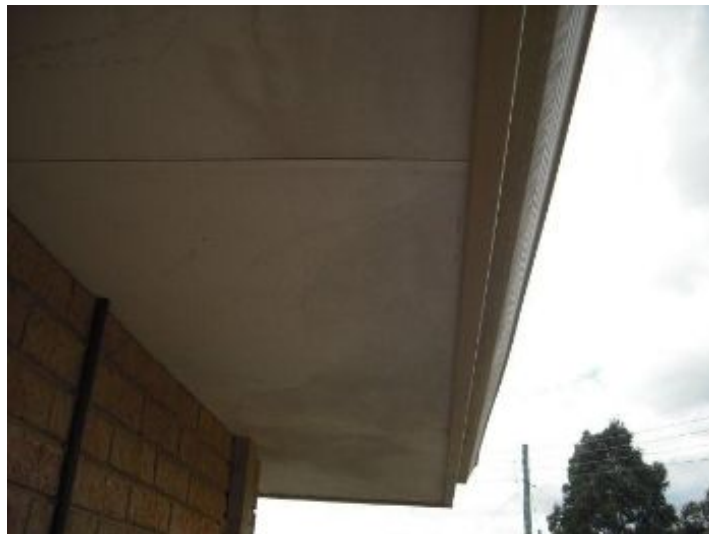
- Water stains were noted under the eaves which is an indication that the gutters have overflowed in the past.

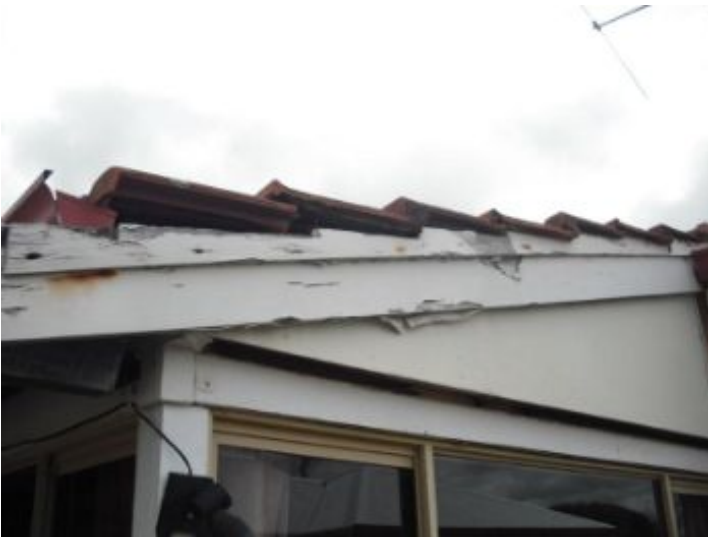
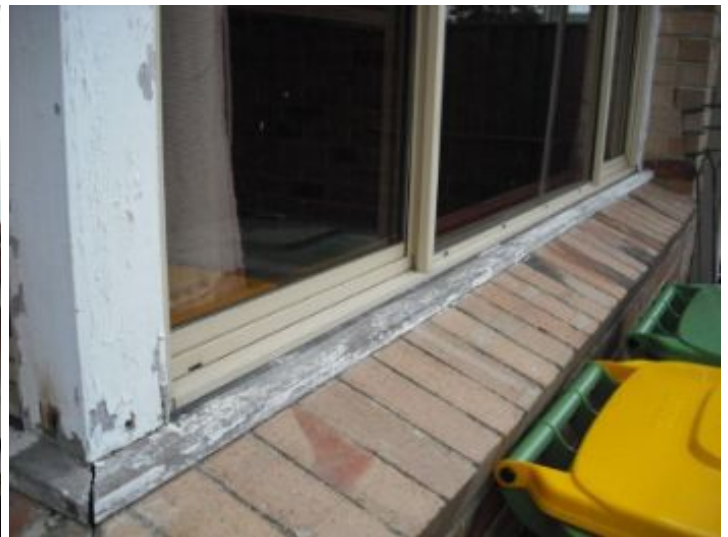
- Exposed wood surfaces observed. Wood rot & deterioration can occur. Prep, prime and paint wood trim surface where paint is peeling or missing.

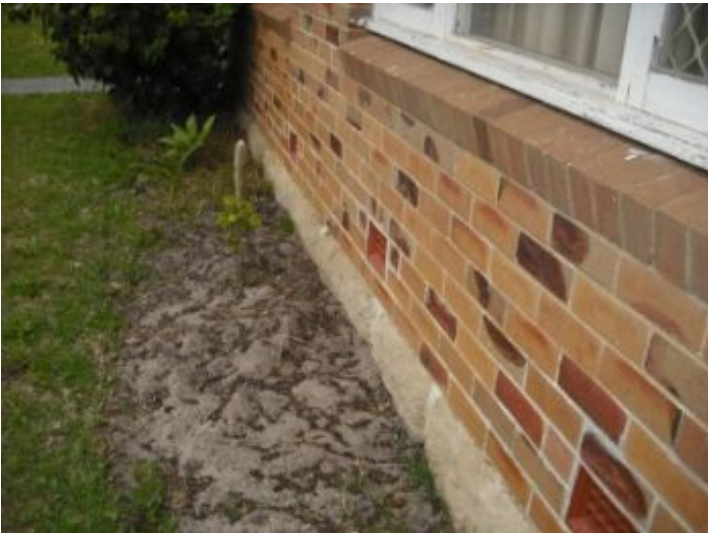
- There are a number of flower beds which are adjacent to the external walls. This can result in water moisture affecting the structure over time. It is recommended that either the beds be removed or a water barrier be placed between the flower bed and the external walls. If these beds are retained it is important that any watering is directed away from the building and kept to an absolute minimum and is controlled.
- A lintel is normally a steel angle section that supports brickwork over a window or door opening. There are lintels located in the external walls located ????? which have surface rust. If these lintels continue to rust they may expand causing horizontal cracks in the brickwork being supported. It is recommended that the lintels are prepared and painted with a rust guard coating to prevent any further rust from occurring.

Flower beds

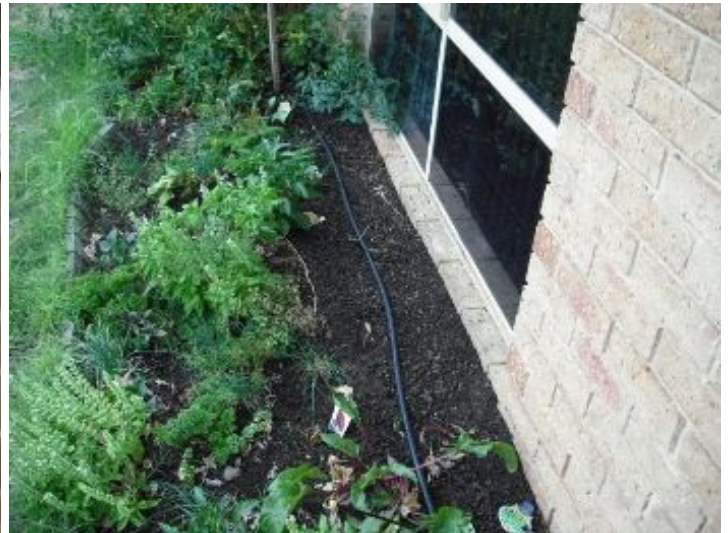
Flower beds

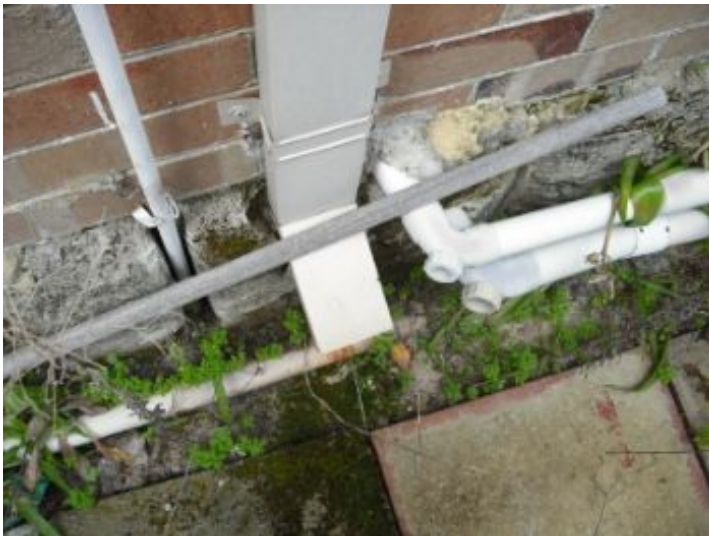
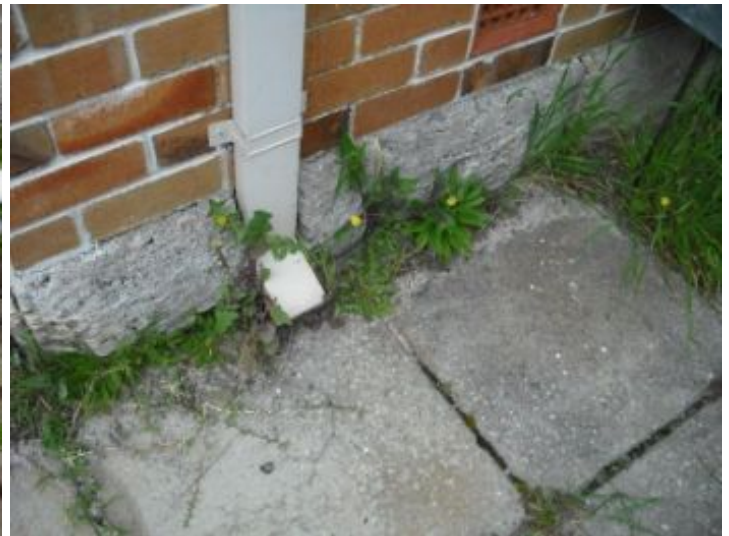
- Some of the down pipes do not have soak wells installed. This allows the water discharged to pool beside the external walls and soak in adjacent to the structure. This can cause foundation settlement, dampness in external walls and can create an ideal environment for termites. It is recommended that either soak wells be installed at least 3 meters away from the building for all downpipes or alternatively all water is directed at least 3 metres away from the external walls.

No soakwells

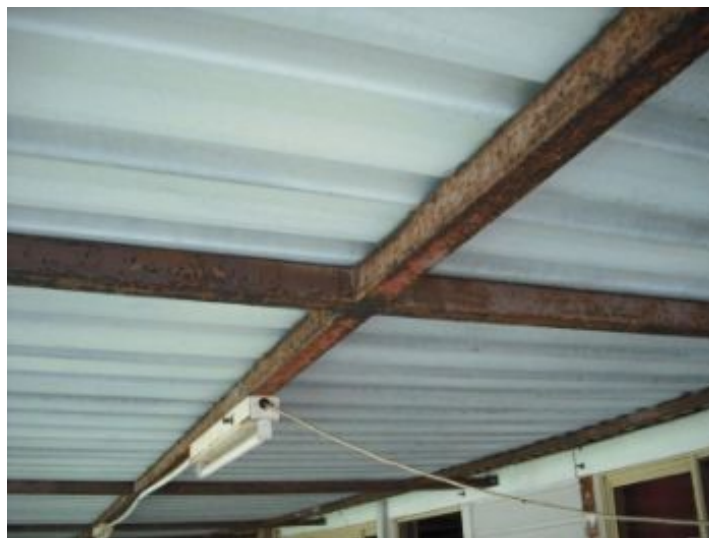
- Appears in satisfactory and functional condition with normal wear for its age. Appears to be sound structure. Some maintenance and painting of the steel structure is required.
