Home Inspection Report

86 Right Lane, Rightsville WA, 6006
Inspection prepared for: John Wright
Inspection Date: 28/2/2010 Time: 2.30 pm
Age: 1982
Weather: Fine and hot

Inspector: Paul Antonelli
Phone: 0400321451
Email: paul@resicert.com
www.perthhomeinspector.com.au

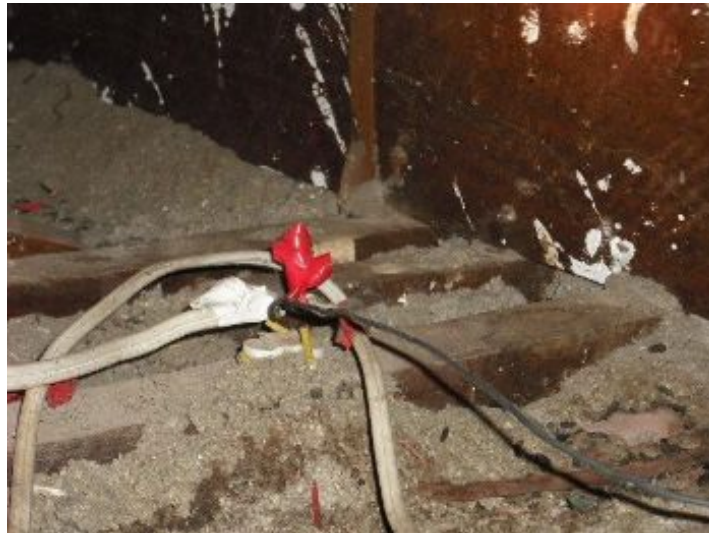
- Wire ends are outside of a Junction Box, which is a potential shock or electrocution hazard.

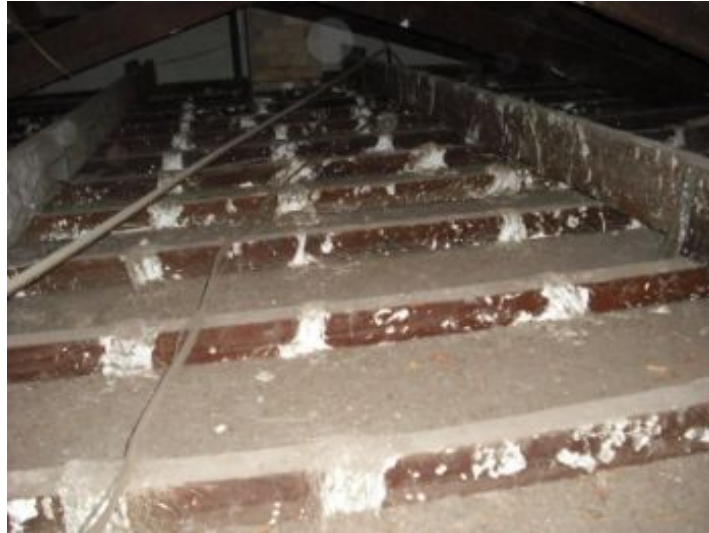
- There is no insulation in the ceiling space. It is recommended that insulation be added to improve the efficiency of the home. You may be eligible for the Federal Government rebate for this.

No insulation

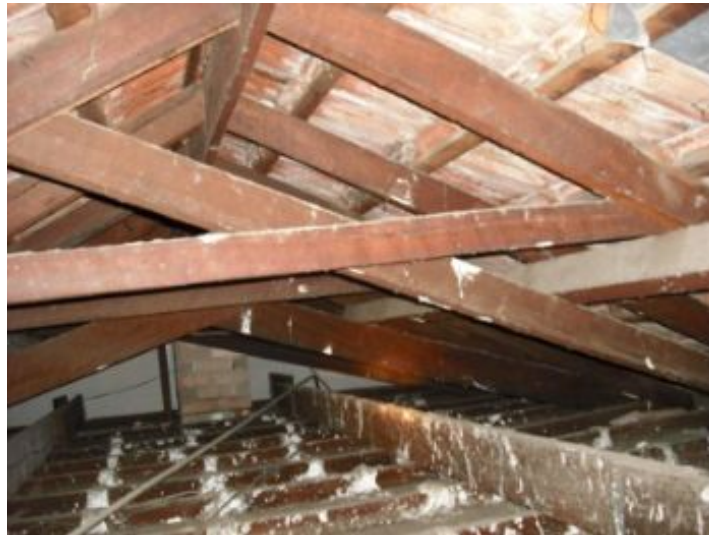
Observations The timber roof structure appears sound, although some minor deflections due to settling in over time were noted.

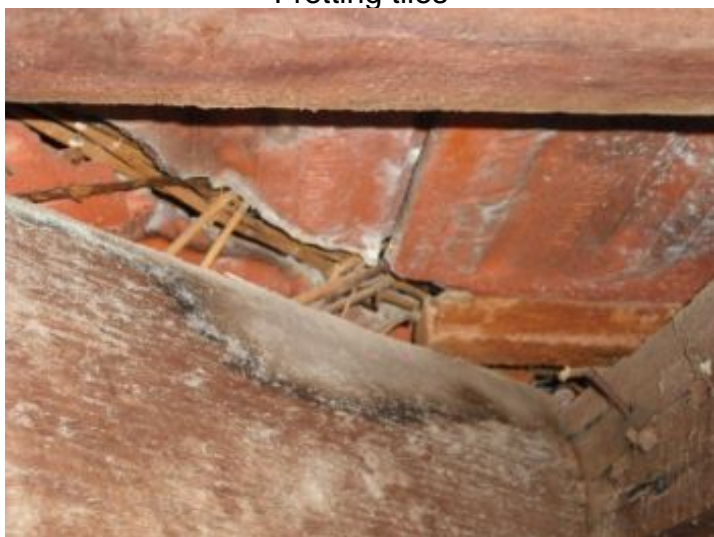
Vine in roof space

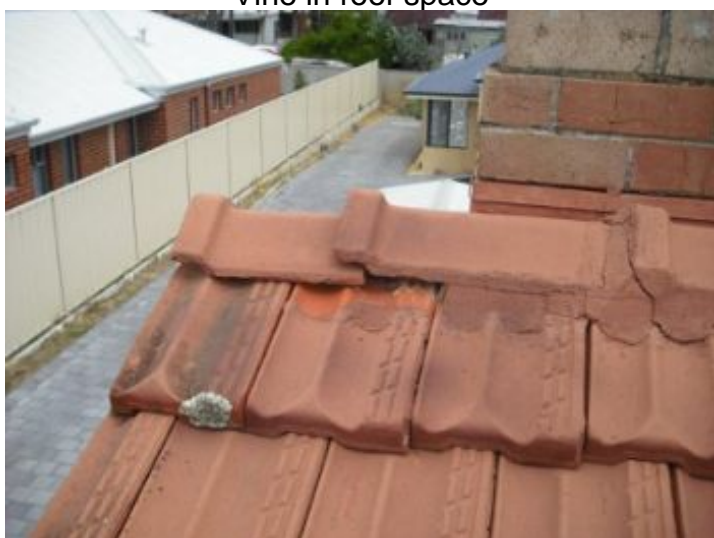
Ridge capping deficient

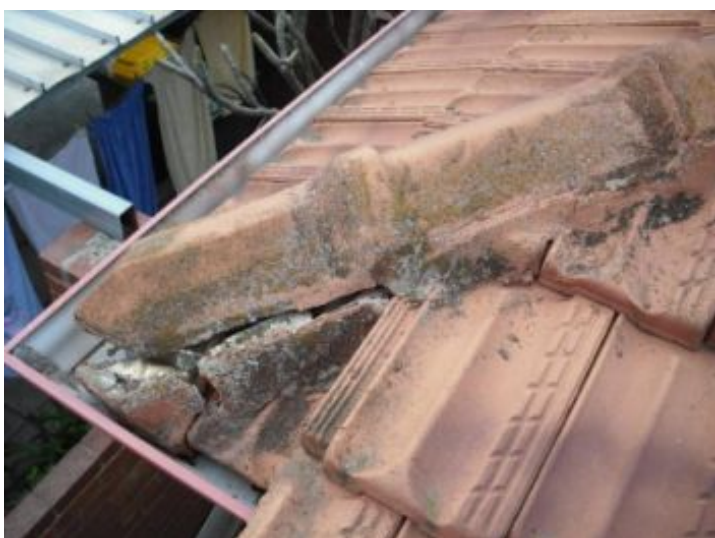
Hip capping deficient

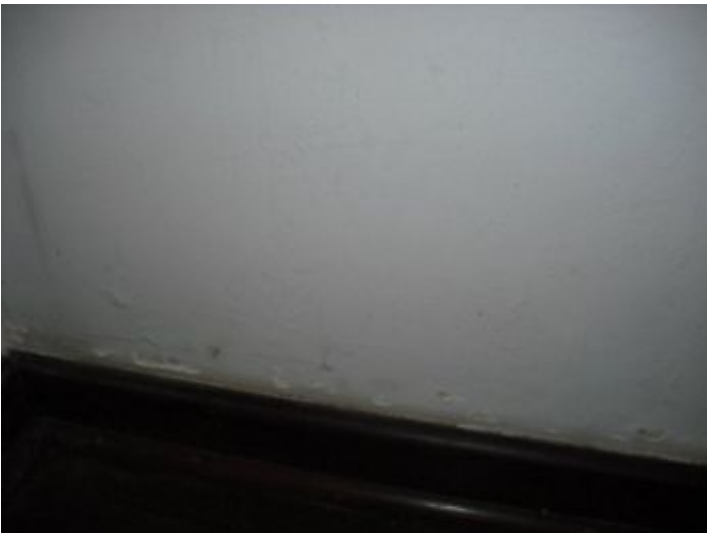
- Due to normal minor differential settlement of the foundations, small cracks have appeared through internal walls at various places throughout the house. These cracks do not appear to have affected the overall structural integrity of the house and can be patched normally.
- There is evidence of dampness in the wall which is adjacent to the shower. This is a result of the seals and tile joints not functioning correctly. The tiles and joints should be checked for leaks and resealed to prevent any further dampness. Then the wall should be allowed to dry out fully before being repaired.

Dampness in walls

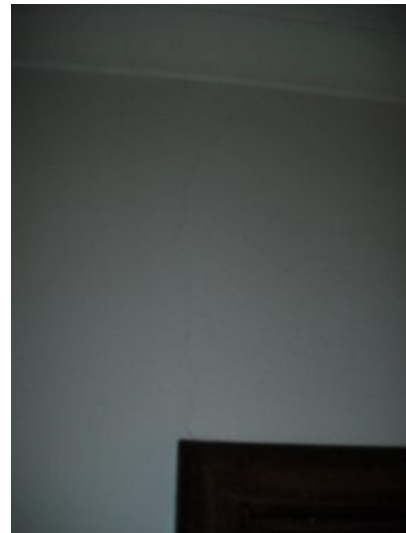
Wall cracks present

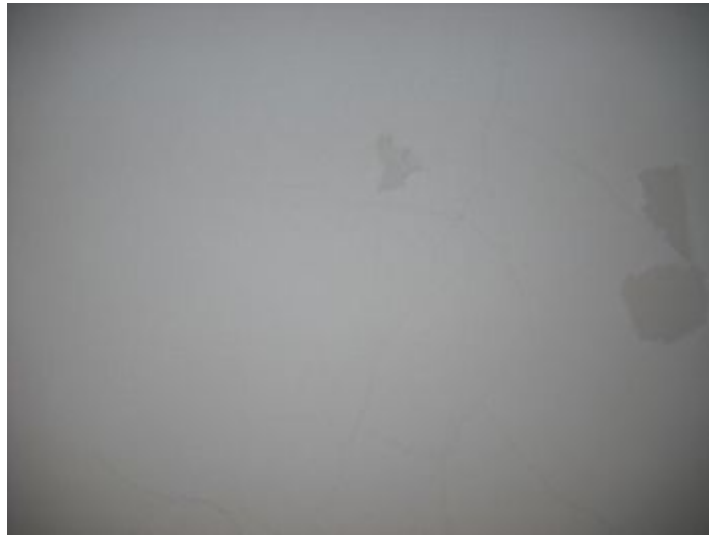
- There is what appears to be old water stains in the lounge ceiling covering. Inspection within the roof space and of the roof covering did not reveal an obvious source of any leak, which is difficult to detect when it is not raining. We suggest that you monitor this area during heavy rainfall to confirm whether any maintenance work is required. This is important because our inspection does not warrant or guarantee the roof against leakage.

Old water stains

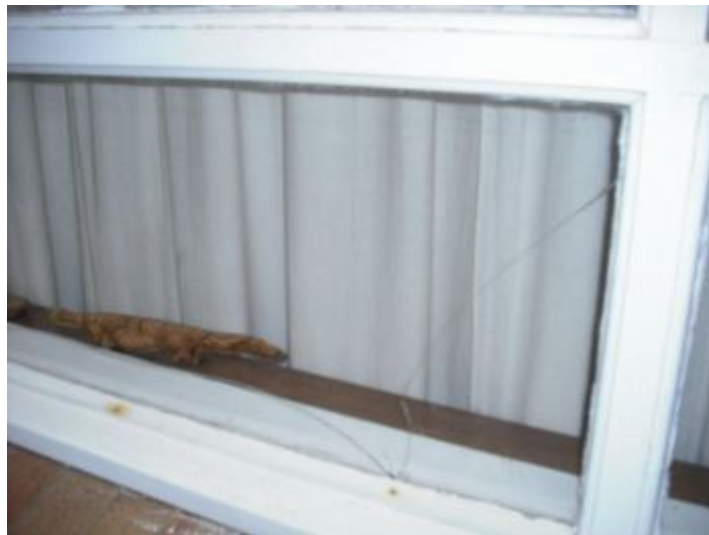
- Broken/cracked glass pane noted, repairs needed.

Cracked pane

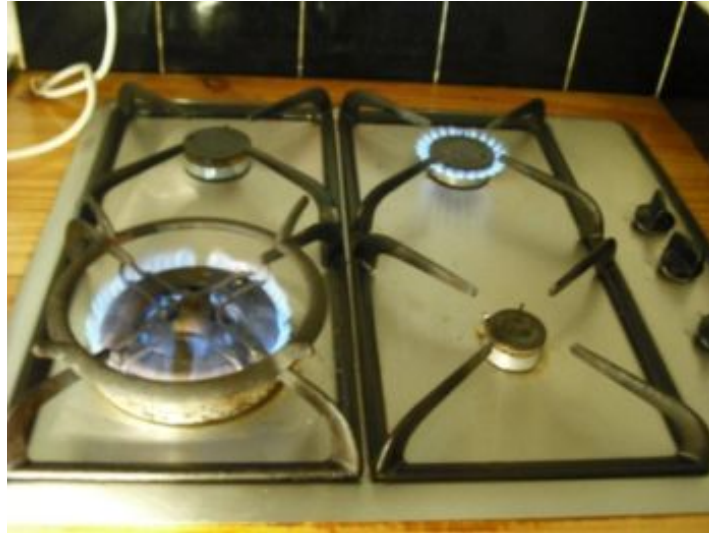
Gas cook top

Observations:
 • The cook top operated to normal user controls. The self igniter on two of the hotplates is not working and requires servicing.

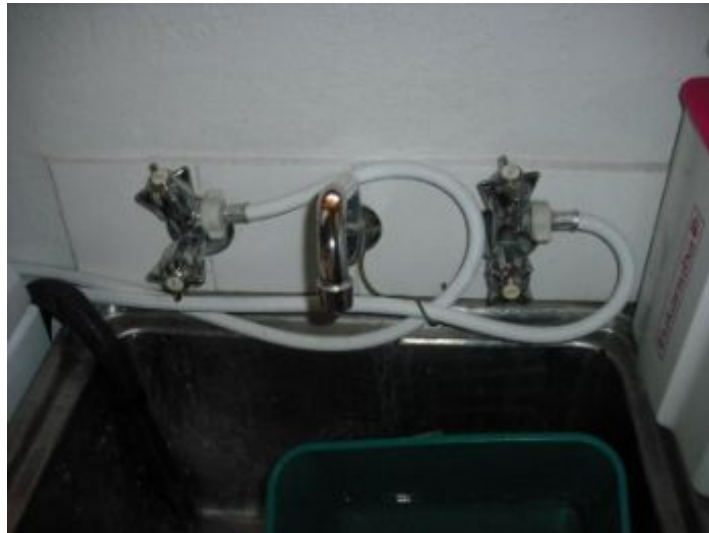
- The trough and related components are functional.
- The hot & cold water supplies are reversed. This is not a functional problem but to someone who is not familiar with this condition unexpected hot water could scald them. We suggest contacting a qualified plumbing contractor to repair.

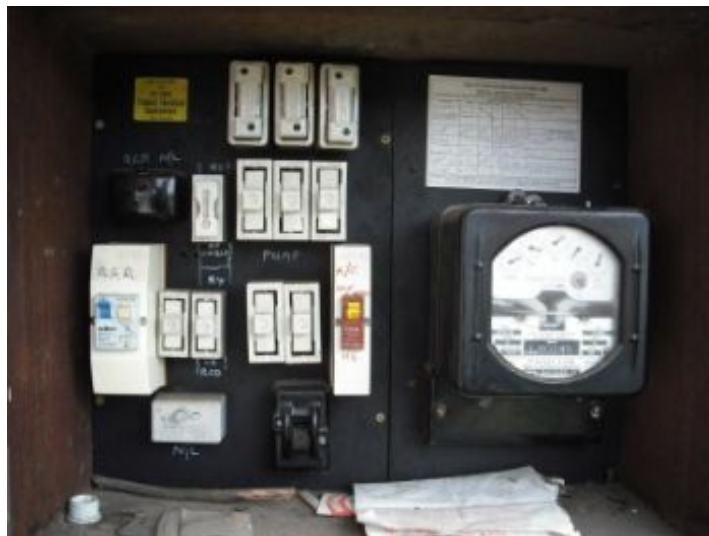
- One RCD (Safety Switch) has been installed. In line with the latest regulations another RCD safety switch is required to be installed prior to settlement. This is required to be carried out by the vendors.

One RCD. Another required.

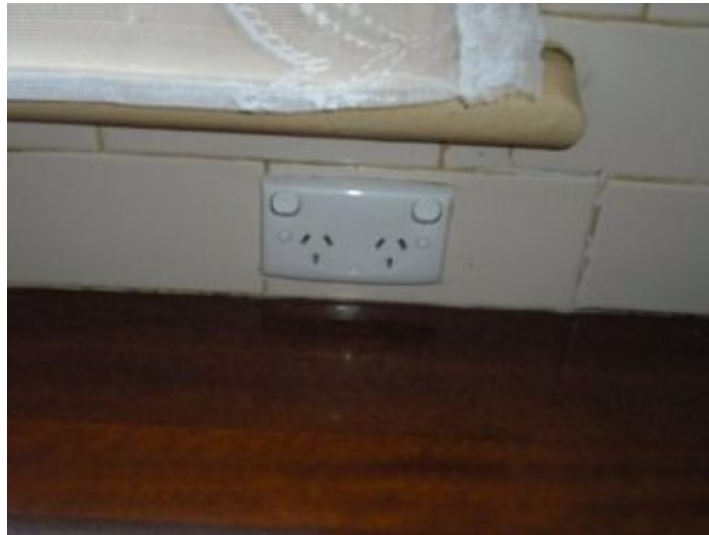
- There is a loose power point fitting located in the bar area that needs refixing to the wall.

Loose power point

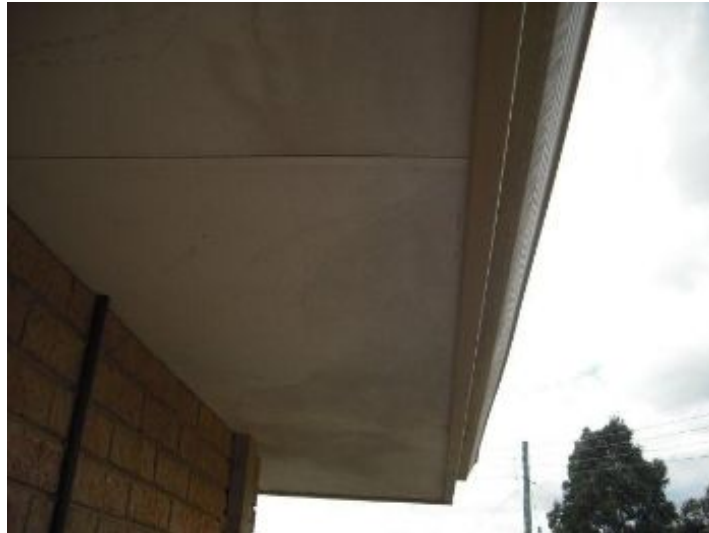
- Water stains were noted under the eaves which is an indication that the gutters have overflowed in the past.

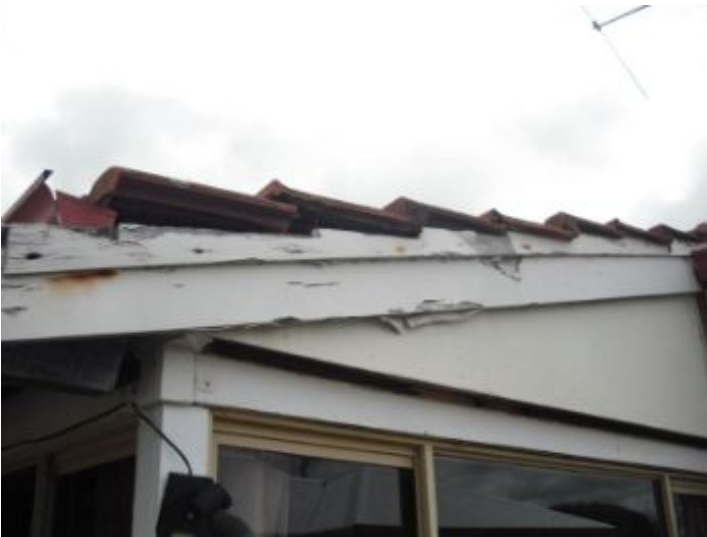
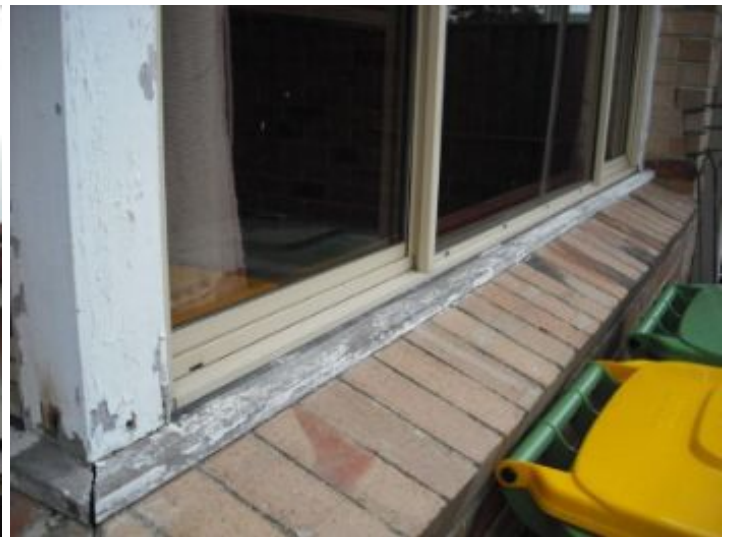
- Exposed wood surfaces observed. Wood rot & deterioration can occur. Prep, prime and paint wood trim surface where paint is peeling or missing.

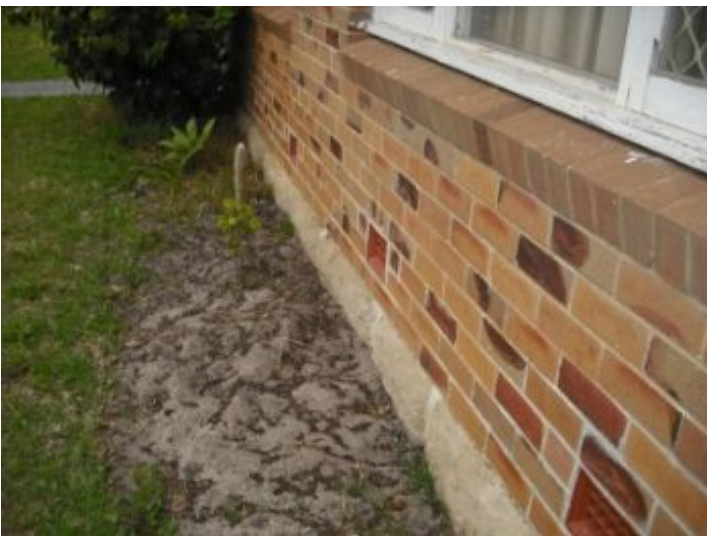
- There are a number of flower beds which are adjacent to the external walls. This can result in water moisture affecting the structure over time. It is recommended that either the beds be removed or a water barrier be placed between the flower bed and the external walls. If these beds are retained it is important that any watering is directed away from the building and kept to an absolute minimum and is controlled.
- A lintel is normally a steel angle section that supports brickwork over a window or door opening. There are lintels located in the external walls located ????? which have surface rust. If these lintels continue to rust they may expand causing horizontal cracks in the brickwork being supported. It is recommended that the lintels are prepared and painted with a rust guard coating to prevent any further rust from occurring.

Flower beds

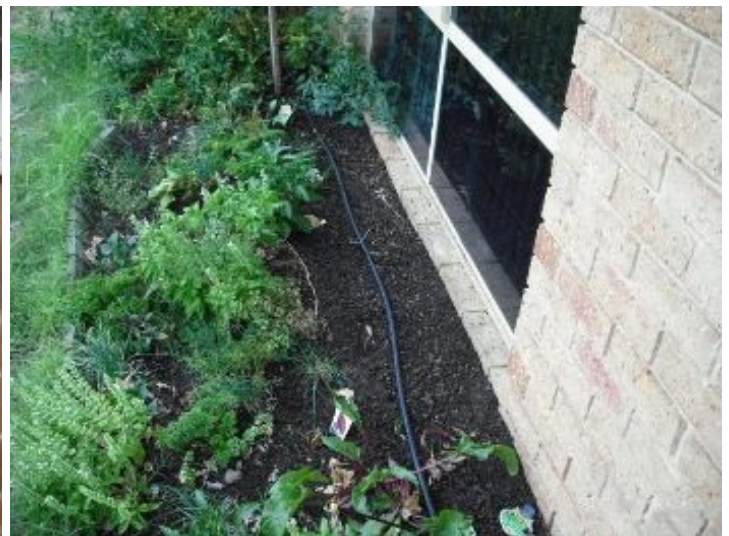
Flower beds

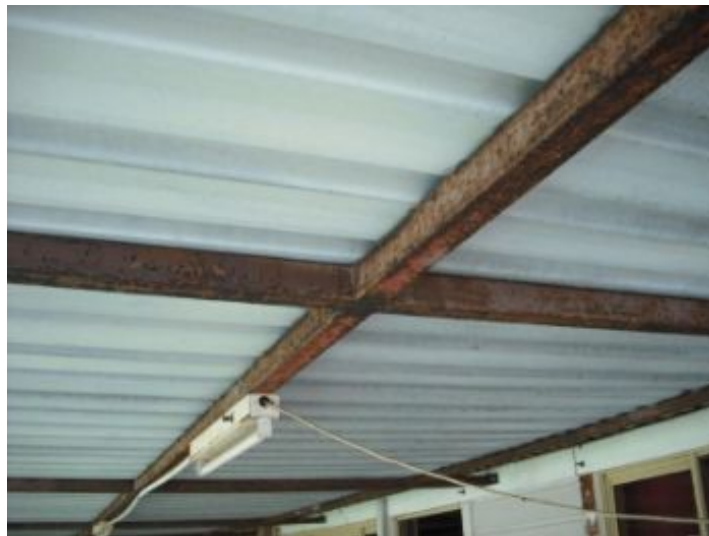
- Appears in satisfactory and functional condition with normal wear for its age. Appears to be sound structure. Some maintenance and painting of the steel structure is required.
